# Report to Congress: Photographic Review of HUD-Assisted Properties

*07/03/2019*

**OFFICE OF POLICY DEVELOPMENT AND RESEARCH**

**UNITED STATES DEPARTMENT OF HOUSING AND URBAN DEVELOPMENT**

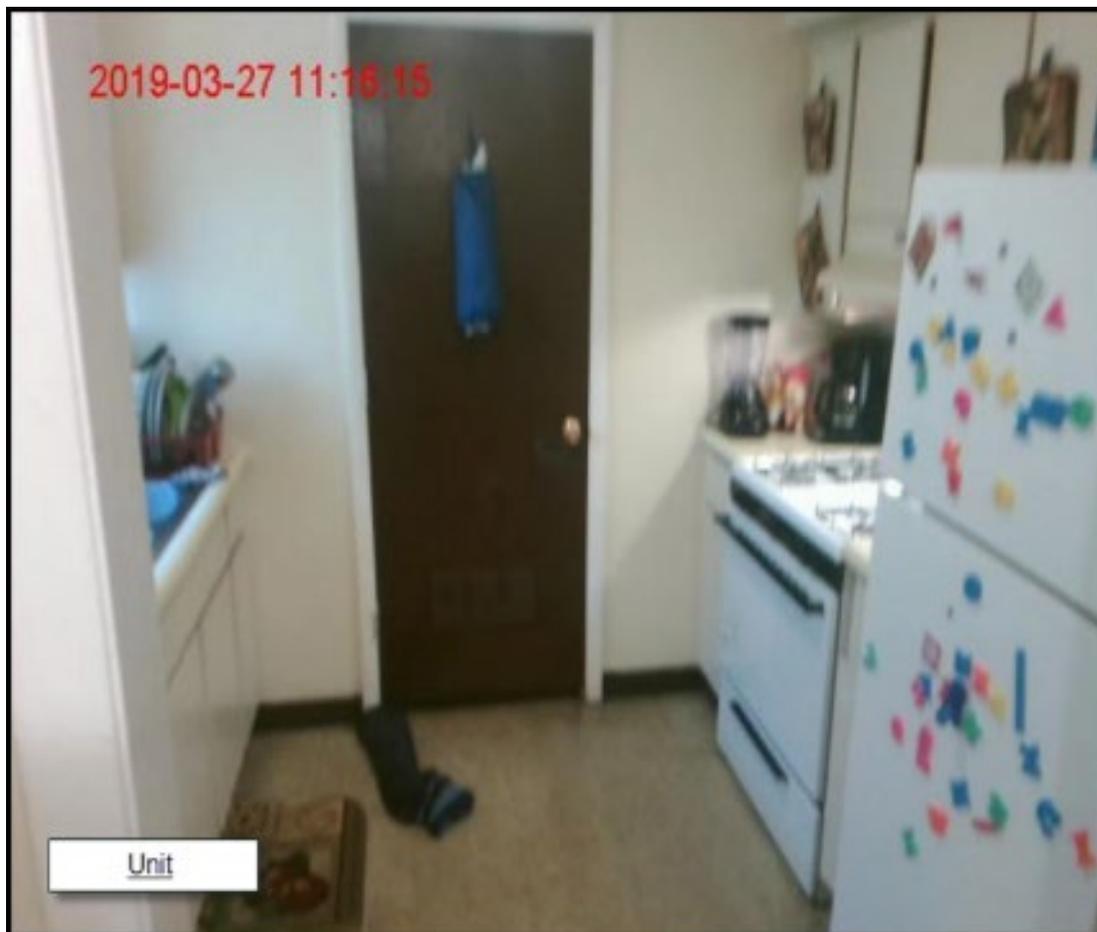
Exhibit 4: Unit Inspection Within the Trinity Manor Apartments

Exhibit 4 displays a unit from the Trinity Manor Apartments, in Augusta, GA. The apartment complex was inspected on March 27, 2019, and received an overall inspection score of 36c\* (HUD, n.d.c). The asterisk indicates that health and safety (H&S) deficiencies were found with respect to smoke detectors and lowercase “c” indicates that one or more exigent/fire safety (calling for immediate attention or remedy) H&S deficiencies were observed. The unit’s door is displayed in the photo; however, it does not reveal the type of door (for example, closet, bathroom, entry) nor whether its locks are damaged or inoperable. One would need to physically operate the door to determine where it leads and whether the locks are functioning properly.

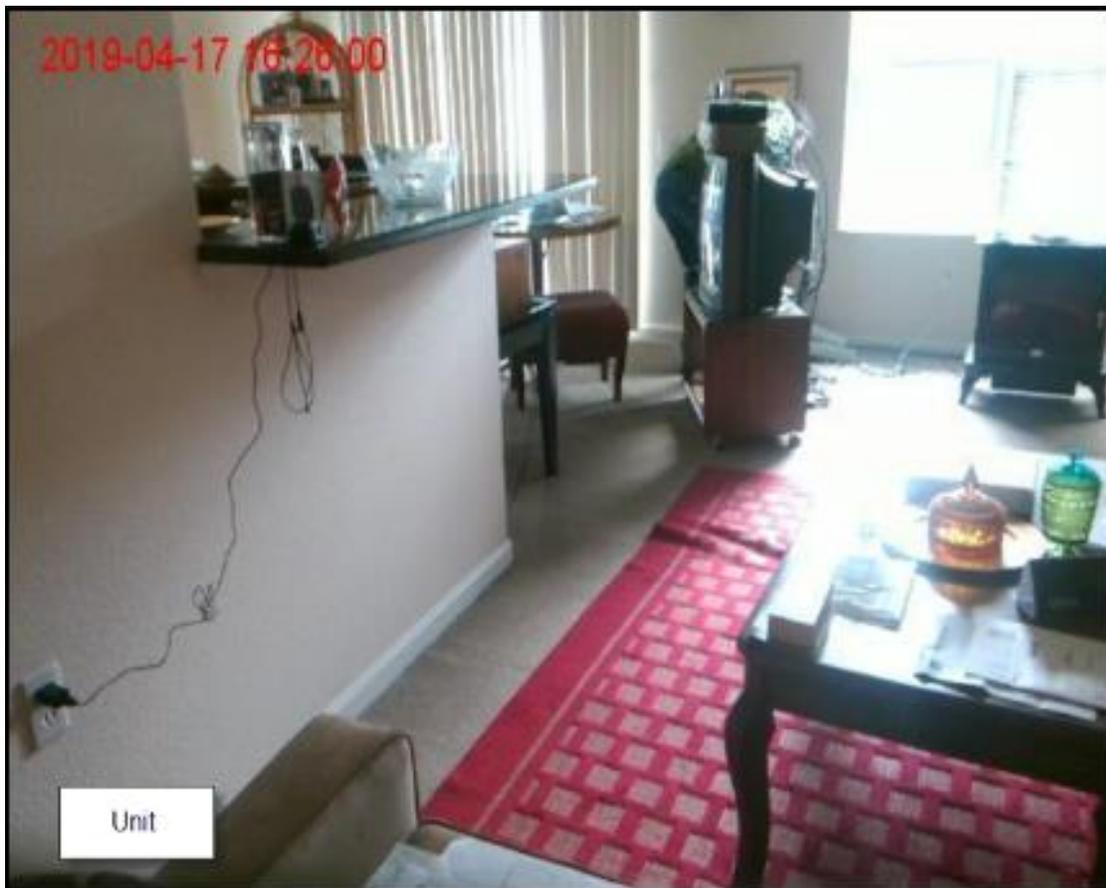
Exhibit 5: Unit Inspection Within The Lakewoods II Complex

Exhibit 5 displays a unit from the Lakewoods II complex, in Toledo, Ohio. This complex was inspected on April 17, 2019, and received an overall inspection score of 71c\*. The figure displays the unit's windows; however, it does not reveal whether the windows' screens were missing or damaged, have adequate caulking, nor whether locks are damaged or operable. Similarly, one would need to physically inspect and operate the windows to determine if the screens were present and undamaged, caulking was missing or deteriorated, and the locks are functioning properly.
